Eric D. Hildebrand
Frank R. Wilson
Transportation Group
University of New Brunswick
Canada

FINDINGS FROM A LEVEL III HEAVY TRUCK STUDY

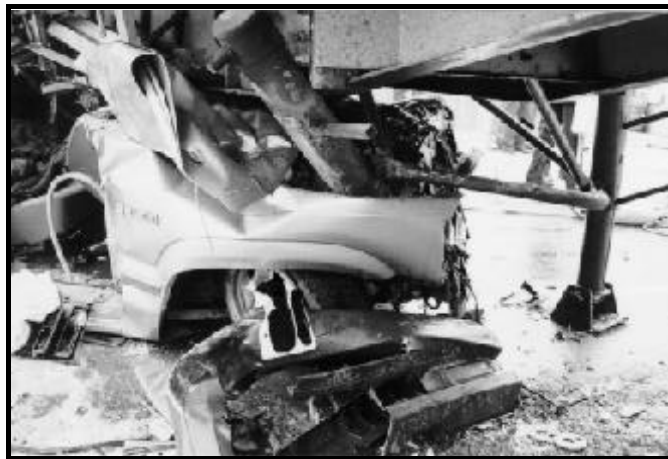
The classic side underride case is considered that of a T-type configuration which often occurs as a heavy vehicle crosses the path of an oncoming vehicle. A case involving an unstable B-train combination which slid perpendicular into an oncoming passenger vehicle exemplified this type of collision (Figure 1). Trailer swingout is not an uncommon occurrence. The UNB team, outside of this study, have investigated three other cases - one being another B-train. All trailer swingouts investigated have occurred under unloaded conditions.

Figure 1: Swingout Resulting in Side Underride

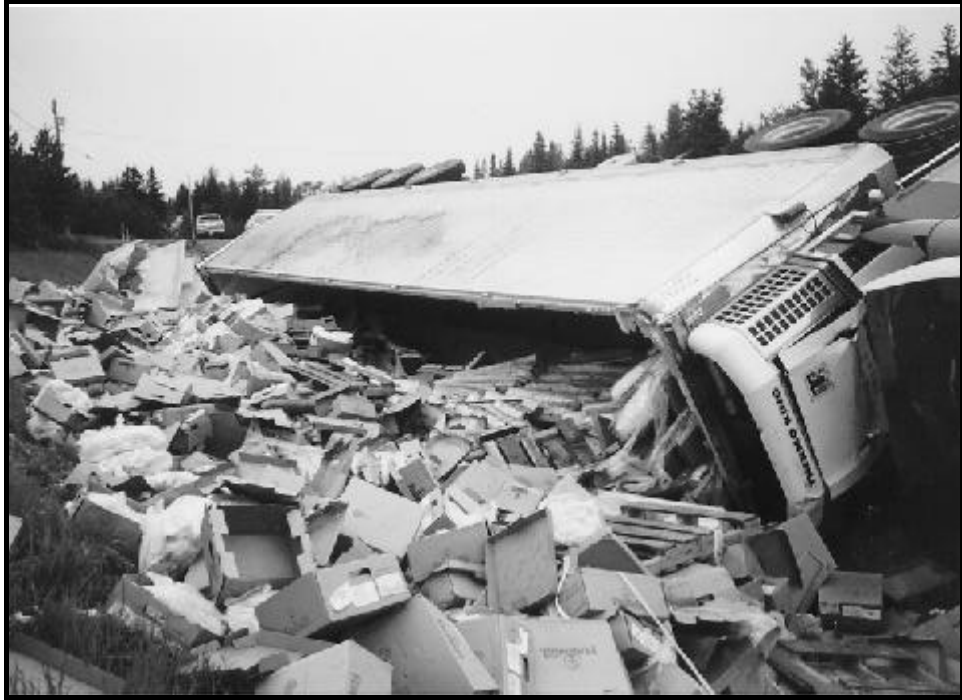
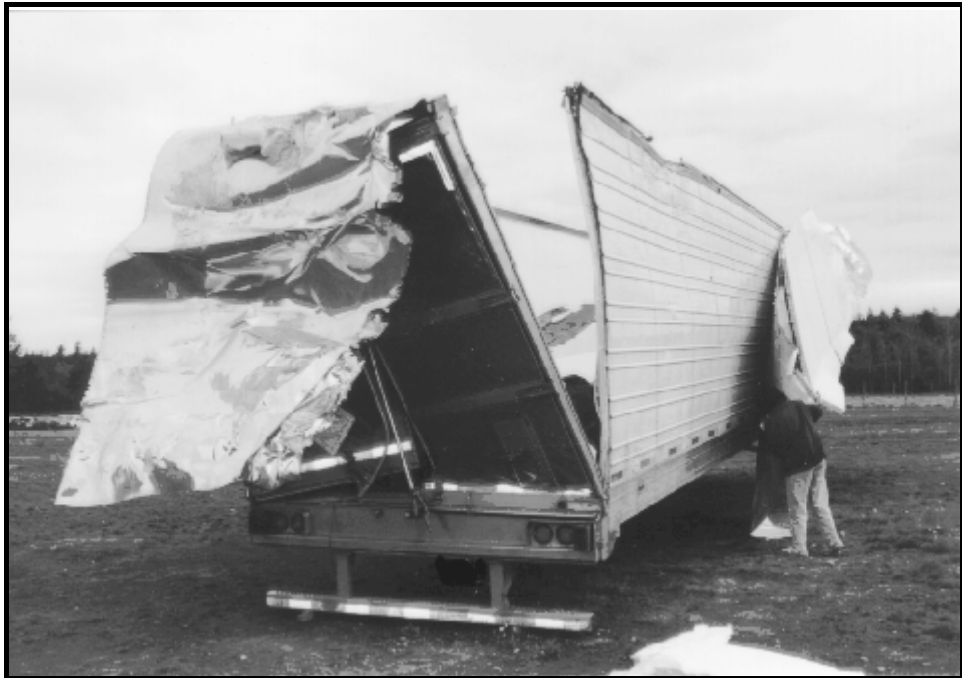
The structural integrity of van semi-trailers failed in a number of cases resulting in loadspill of the contents. Nine cases studied had loadspills as a result of the van roof or sides being torn open during the rollover sequence (see Figure 2). This was often due to external forces (tree, utility pole, rock, etc.) but also due to internal loading by the cargo. Provisions were normally made to provide lateral load support; however, in several cases the load had not *cubed-out* resulting in a significant amount of free-space between the top of the load and the vanroof. During rollover the load shifted vertically and punctured the roof panels. Case HFVP-1201 is a typical example which involved compressed gas cylinders that were ejected through the roof during rollover.

Figure 2: Loss of Semi-Trailer Integrity

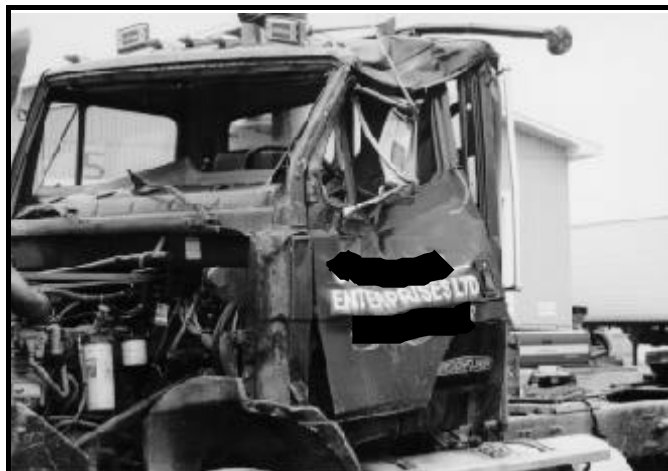
The analysis of the cases studied relative to the crash worthiness of the tractor units yielded useful data. Of the 55 cases, 33 resulted in a rollover (of at least ¼ turn) of the tractor unit. The most obvious problem noted was that of windshield retention. Over 80% of those tractors which rolled, lost at least partial bonding between the windshield and the frame. Surprisingly, 18 of the 26 cases involving bond separation yielded total separation. This is a loss of occupant compartment integrity which obviously compromises occupant safety. Figure 3 illustrates a typical case where the windshield has completely separated from its frame despite the tractor having only been involved in a relatively minor rollover. This figure also depicts a problem which has occurred in a number of the rollover cases studied. The *westcoast* mirrors will often be deformed rearward and actually intrude into the occupant compartment during the sequence of a rollover. No injuries have been reported as a direct result of the intrusion of the mirror assembly into the occupant compartment but the potential does exist.

Figure 3: Windshield Bond Separation and Mirror Assembly Deformation

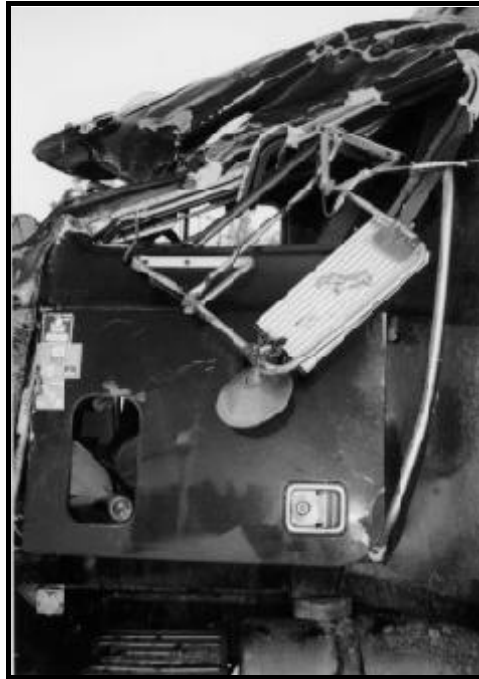
The second main finding relative to crash worthiness of tractors is the apparent lack of roof and A-pillar integrity in the event of a rollover collision. A total of 12 of the 33 rollover cases were noted where extensive roof intrusion and A-pillar collapse was evident. Figure 4 depicts a typical example. This lack of structural strength compromises the integrity of the so called *greenhouse* or occupant compartment in the event of a rollover collision. There were several cases where the vehicles only underwent a 1/4-roll (i.e. onto its side) yet significant A-pillar intrusion resulted.

Figure 4: Cab Roof Collapse of Tractor

Perhaps the most blatant finding of the study is the lack of occupant protection afforded the occupants of a road tractor in the event of a rollover. As a result, it is recommended that the extension of a revised Canadian Motor Vehicle Safety Standards (CMVSS) #212 *Windshield Mounting* and #216 *Roof Intrusion Protection* directed to heavy trucks should be considered. These standards currently only apply to passenger vehicles.

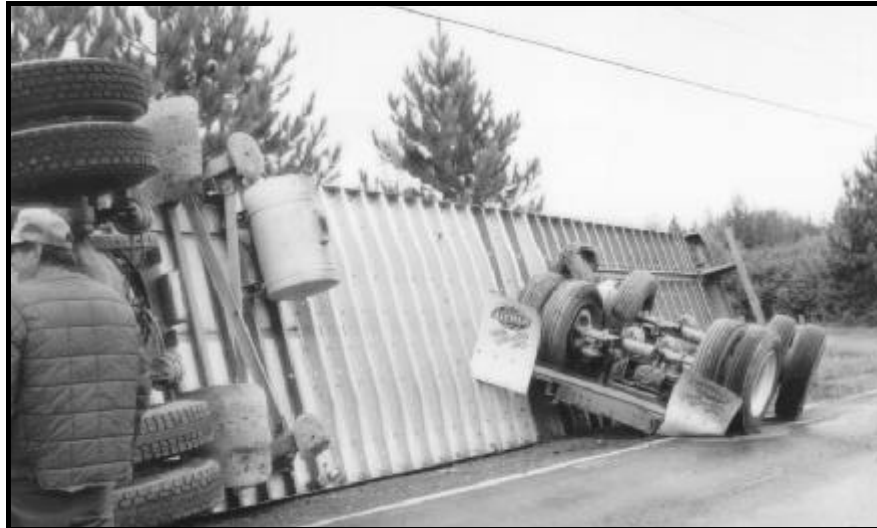
Two cases occurred (HFVP-1222 and AFS-S-1214) where the dual tandem axle assembly separated from the semi-trailer frame (see Figure 5). Both semi-trailers permitted the longitudinal adjustment of the axle assembly position with parallel frame members on the outboard sides of the assemblies. The frame members had several holes to accept a holding pin from the axle assembly. In both cases, the application of a lateral force component essentially spread the frame securing the assembly in place allowing it to separate from the semi-trailer.

Figure 5: Separation of Tandem Axle Assembly
