# Road Safety Audit Guidelines

# **Road Safety Audit Guidelines**

University of New Brunswick  
Transportation Group  
Department of Civil Engineering  
Fredericton, New Brunswick

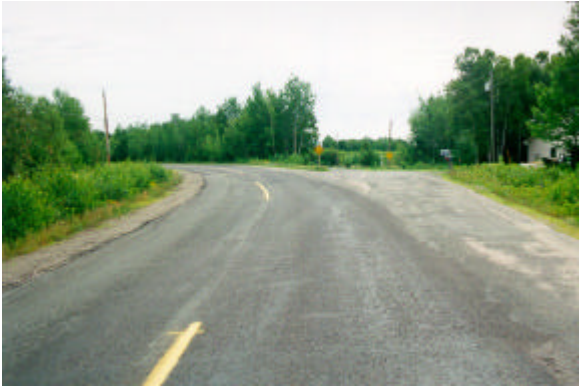
Photo 1. Confusing alignment (intersection with Madison Road)

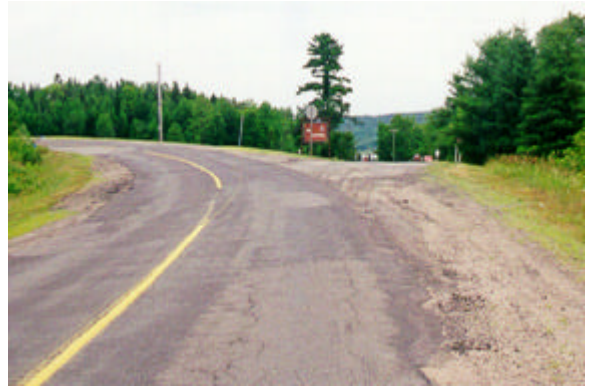
Photo 2. Confusing alignment (intersection with Royal Park)

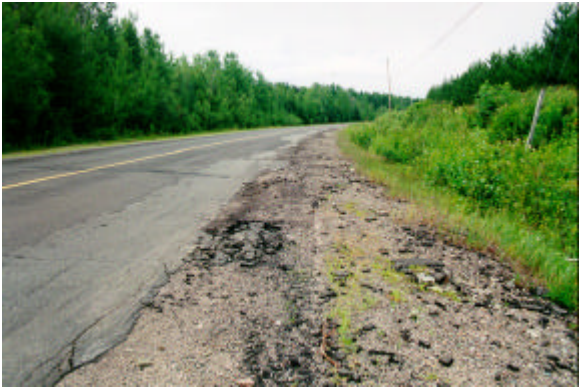
Photo 3. Ravelled pavement edge

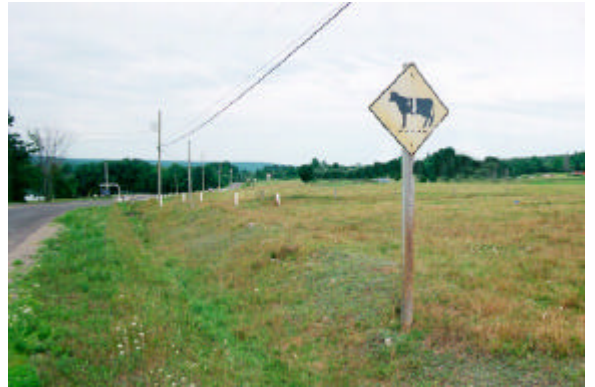
Photo 4. Cracked and faded sign; too much offset

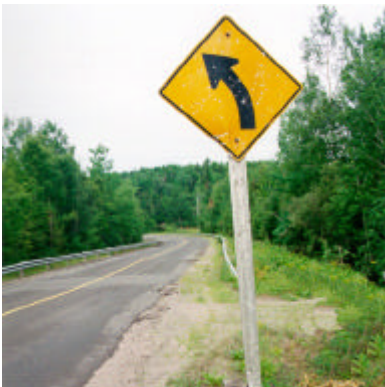
Photo 5. Cracked and non-retroreflective sign.

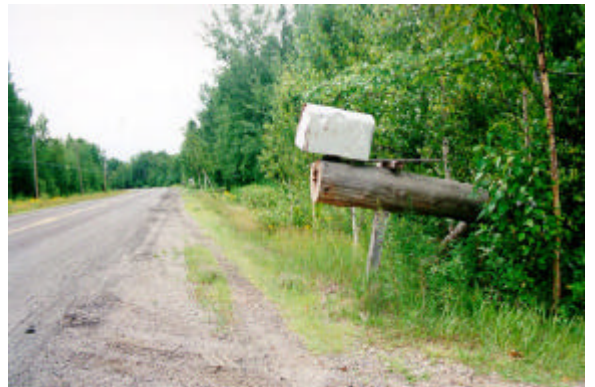
Photo 6. Potentially dangerous mailbox

<p><b>6.7</b> Most mailboxes are located within 2.5 metres from the edge of the pavement. There is one particular case (approximately 28 kilometres west of the intersection of Route 1000 and Route 666) in which the mailbox is mounted on a large wooden log positioned within the clear zone (photo 6).</p>	<p>Have larger mailbox structures either moved outside the clear zone or replaced with “friendlier” frames.</p>	<p>Agree. Will discuss problem with owner.</p>

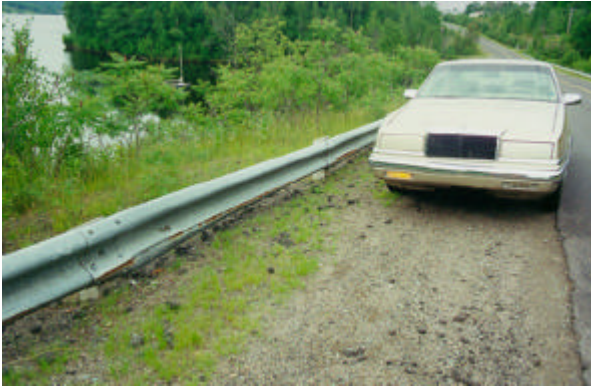
Photo 7. Guiderail too low

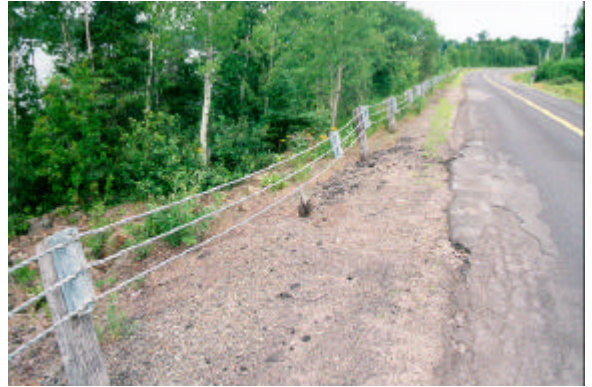
Photo 8. Missing post

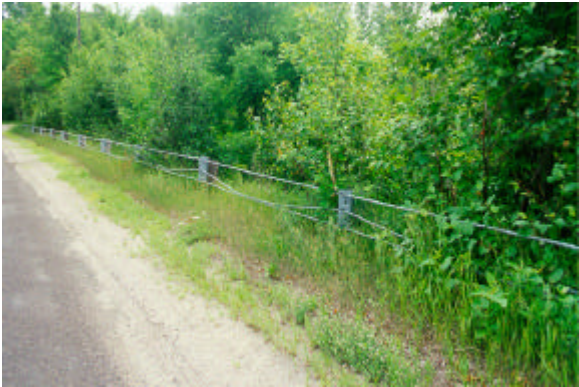
Photo 9. Loose cables

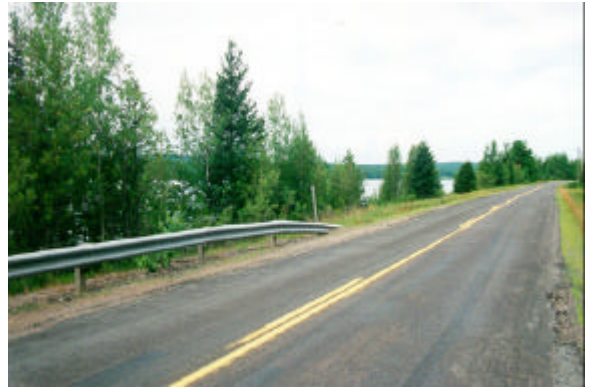
Photo 10. Inadequate coverage of guiderail

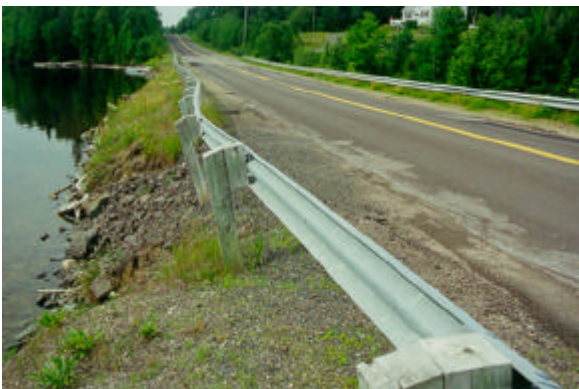
Photo 11. Washed out shoulder

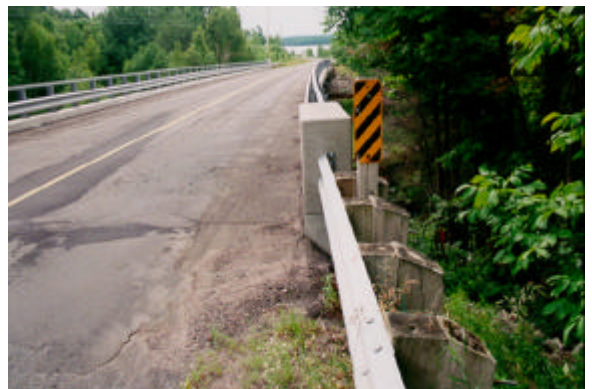
Photo 12. Guiderail not flush with bridge endpost

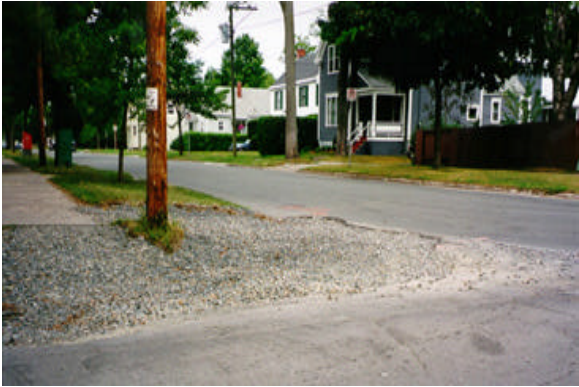
Photo 1. Unsigned construction at intersection

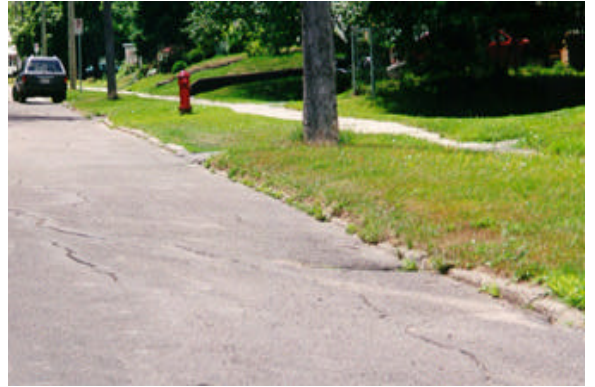
Photo 2. Curbs in disrepair

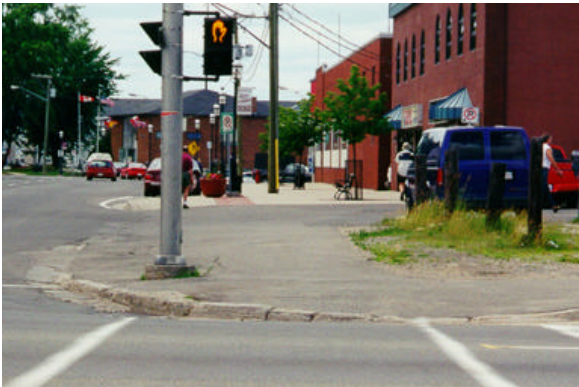
Photo 3. Inadequate curb cut-outs

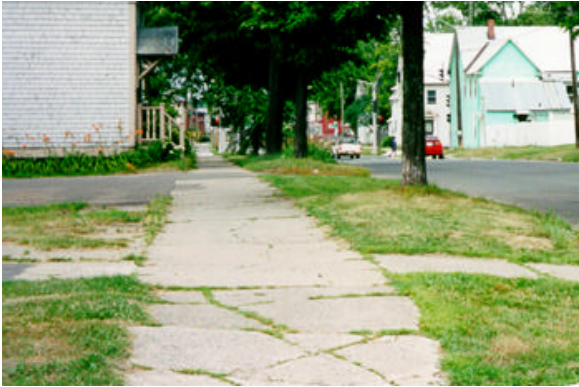
Photo 7. Poor sidewalk condition

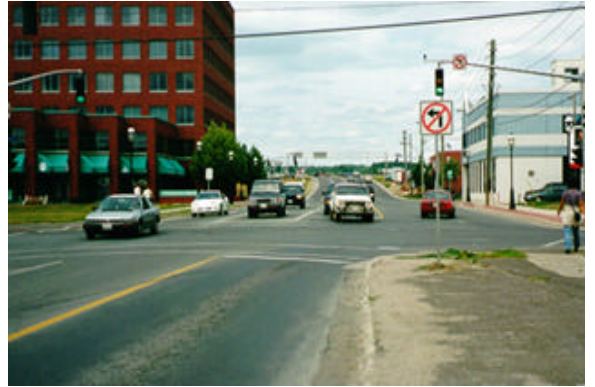
Photo 8. Misaligned intersection

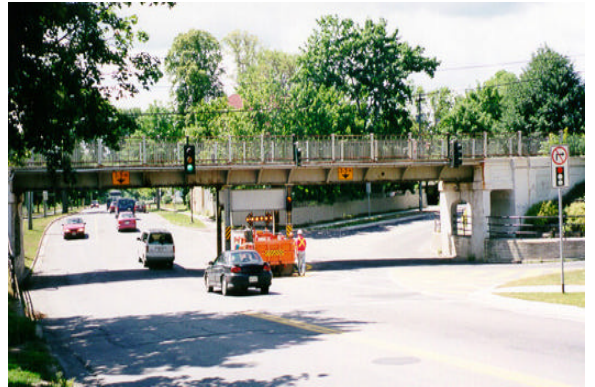
Photo 10. Confusing intersection

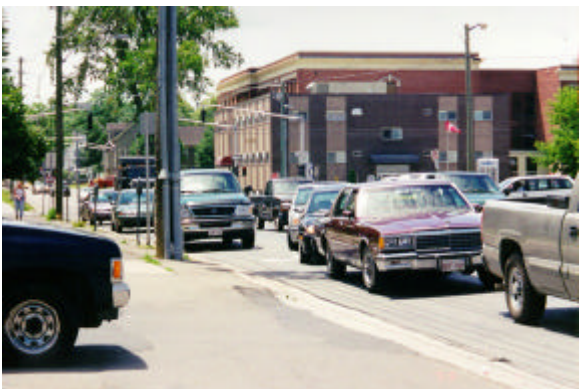
Photo 11. Congestion on a poorly aligned street

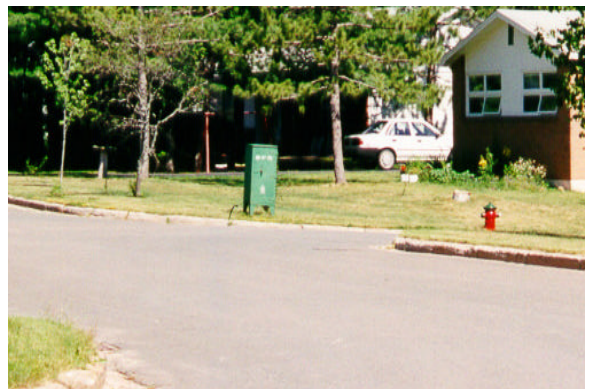
Photo 12. Unsigned intersection

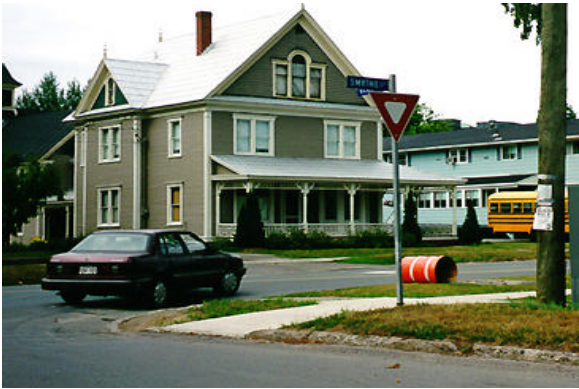
Photo 13. Yield sign where local street meets arterial street

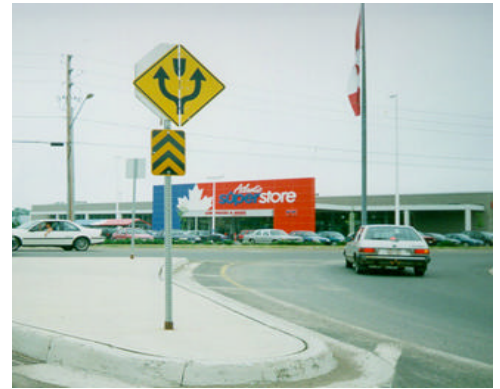
Photo 14. Communicates right-turn lane

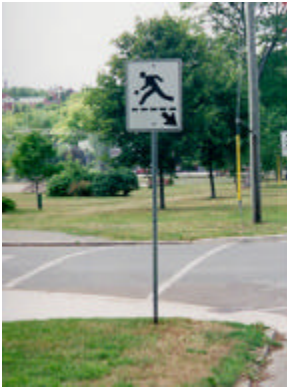
Photo 15. Non-standard crosswalk sign

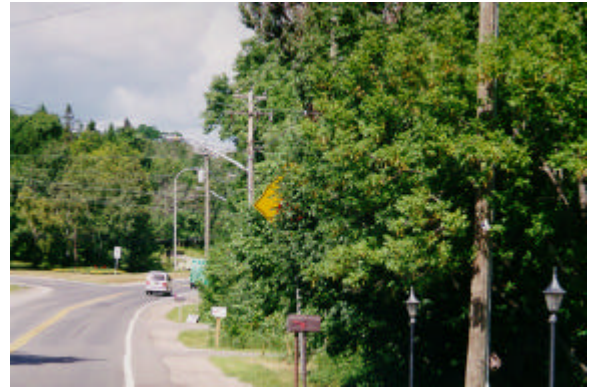
Photo 16. Blocked Stop sign

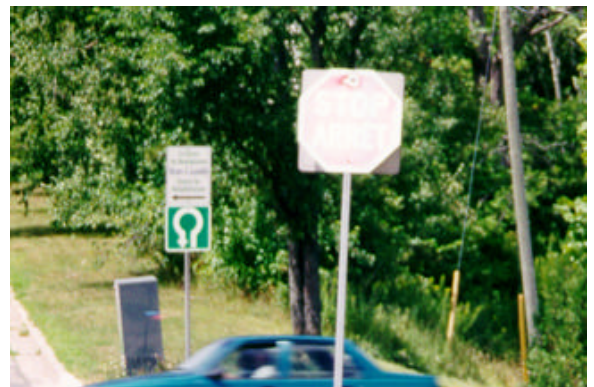
Photo 18. Faded Stop sign

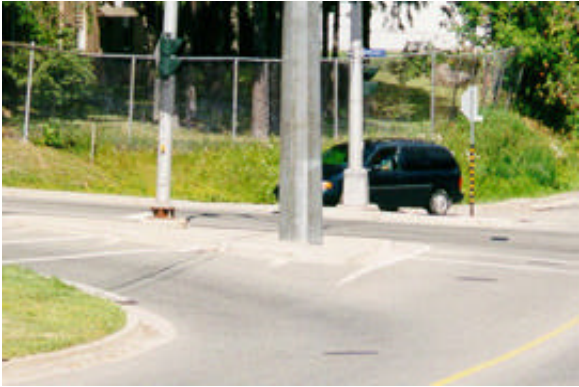
Photo 19. Exposed steel pole

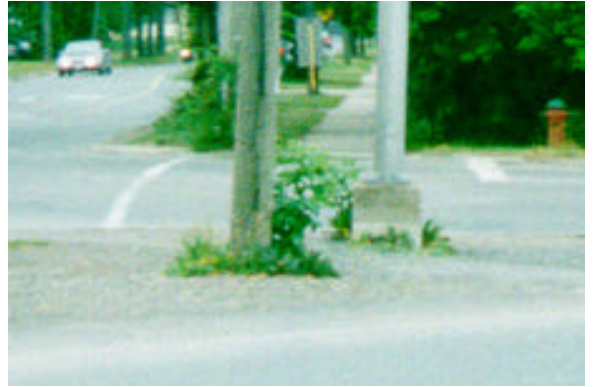
Photo 20. Unprotected pole

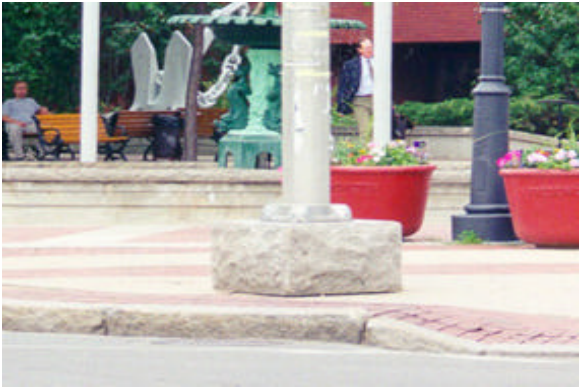
Photo 21. Pole with breakaway support on granite foundation

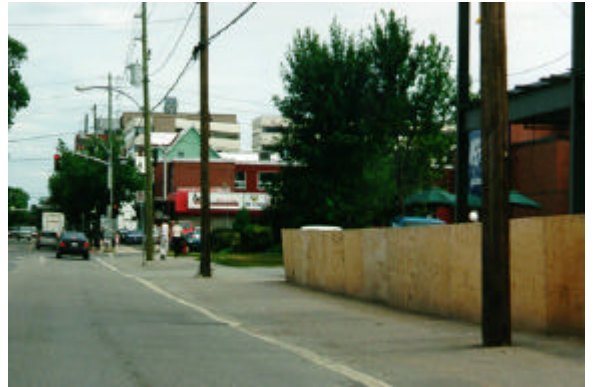
Photo 22. Unprotected poles

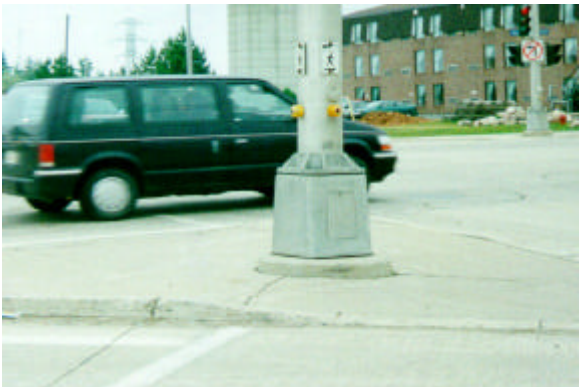
Photo 23. Raised breakaway support

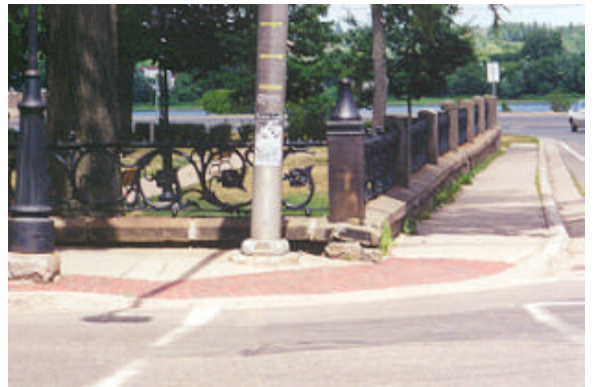
Photo 24. Pole in pedestrian path

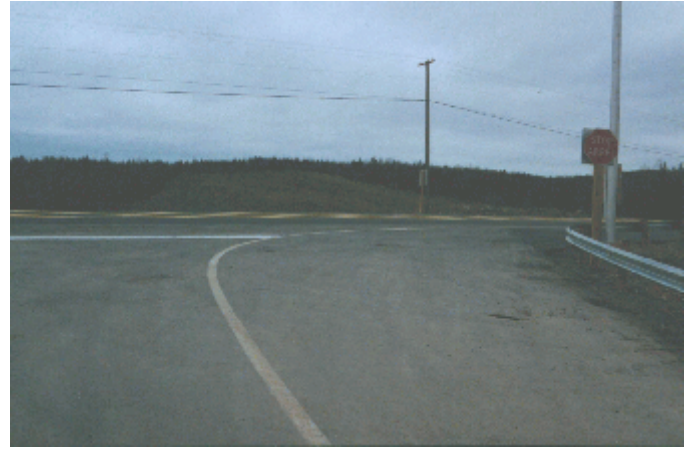
Photo 2: Excessive offset to stop sign (Route 25) off-ramp.

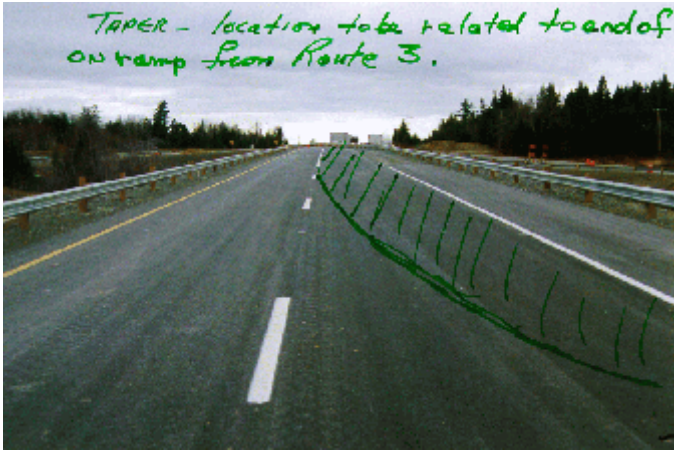
Photo 5: Westbound lane reduction at west end of project

<b>5.0 Lane Alignment</b>			
<b>5.1</b> There is no taper provided to reduce the two westbound lanes to a single lane at the approach to the transition to existing Route 15 (see photo #5).	Provide proper taper and install appropriate advance speed reduction and lane drop warning signs.	Yes	Tapers and advanced speed reduction and lane drop signs will be added.
<b>6.0 Miscellaneous</b>			
<b>6.1</b> The gore between the eastbound onramp from Route 25 and the Route 15 through lanes has asphalt stockpiles.	Remove stockpile.	Yes	Debris will be removed.
<b>6.2</b> Embankment. Section 8.3, page 9, Table 2 of the 50% Design Stage Audit and section 8.3, page 4, Table 1 of the 80% design audit makes reference to width of the top of the embankment.	Upon final construction, it has been noted that full width shoulders have been maintained on the existing embankment (photo #6). Disregard previous audit comments on this item.		No action required.

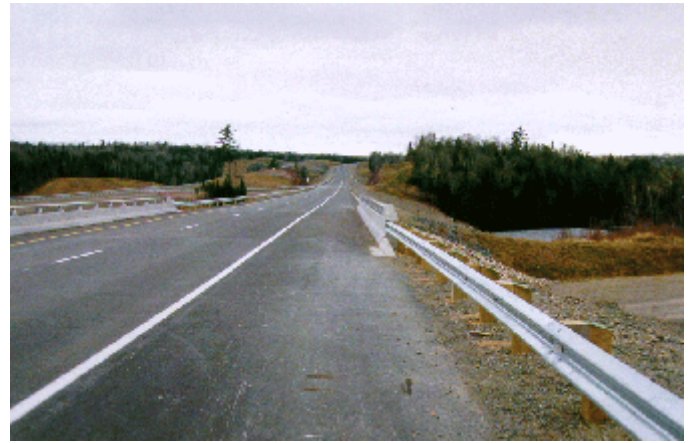
Photo 6: Shoulder width at Hillside Road
