COLLISION PERFORMANCE OF CANADIAN SPORT UTILITY VEHICLES, LIGHT TRUCKS AND MINI-VANS

Eric D. Hildebrand, PhD, PEng
Frank R. Wilson, PhD, PEng

University of New Brunswick Transportation Group
New Brunswick, Canada

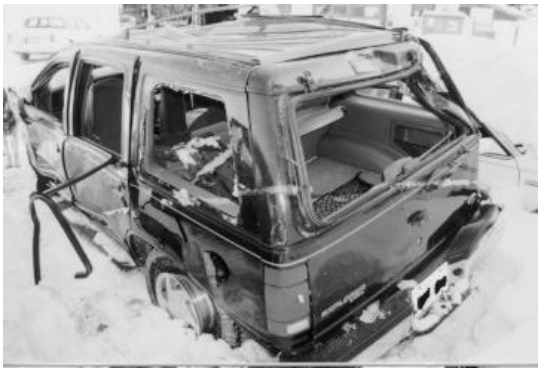
Figure 2: Loss of Side/Rear Glazing

In 49 of the 106 sampled cases, occupant compartment integrity was compromised due to side or rear glazing either shattering or dislodging from its mounting with the window frames. The cases involving this problem are highly correlated to the occurrence of a rollover type collision. While the result of side and rear glazing shattering during a collision has been ever present among passenger cars, the issue has become acute among LTVs given the large openings (and subsequent loss of occupant compartment integrity) created when the glazing materials are no longer present. Figure 2 illustrates a typical case where the rear and all side glazing shattered during a rollover collision resulting in a loss of occupant compartment integrity.

CMVSS 205, Glazing Materials sets out the standards that govern the acceptable types and strengths of materials to be used for glazing. Modifications would be required to this standard for LTVs if the above problem areas are to be addressed.

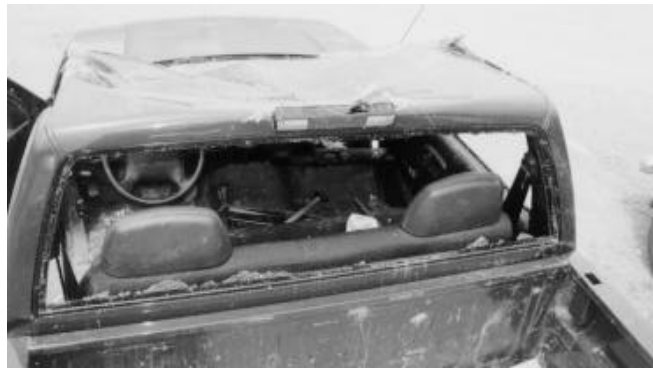
Figure 3: Loss of Rear Glazing

Figure 3, illustrates a similar problem documented for pickup trucks. The rear windows shattered during the sequence of a rollover collision. Again, these occurrences are problematic given the loss of integrity to the occupant compartment.

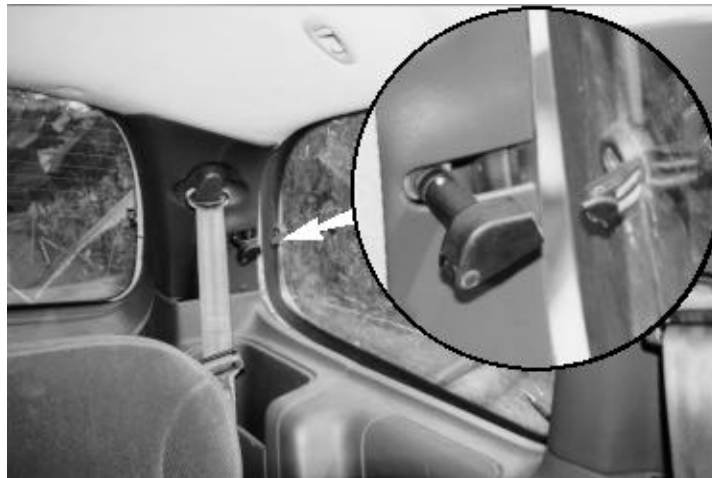
Figure 4: Failure of Side Window Latch

In addition to the cases of glazing materials shattering as noted in the previous section, deficiencies in the mounting mechanisms of side and rear glazing were noted in nine collisions. The latches for side windows were observed to have failed in five cases involving minivans. The result was that the side window either hinged open or (in three instances) became completely detached from the vehicle. Figure 4 depicts a typical occurrence.

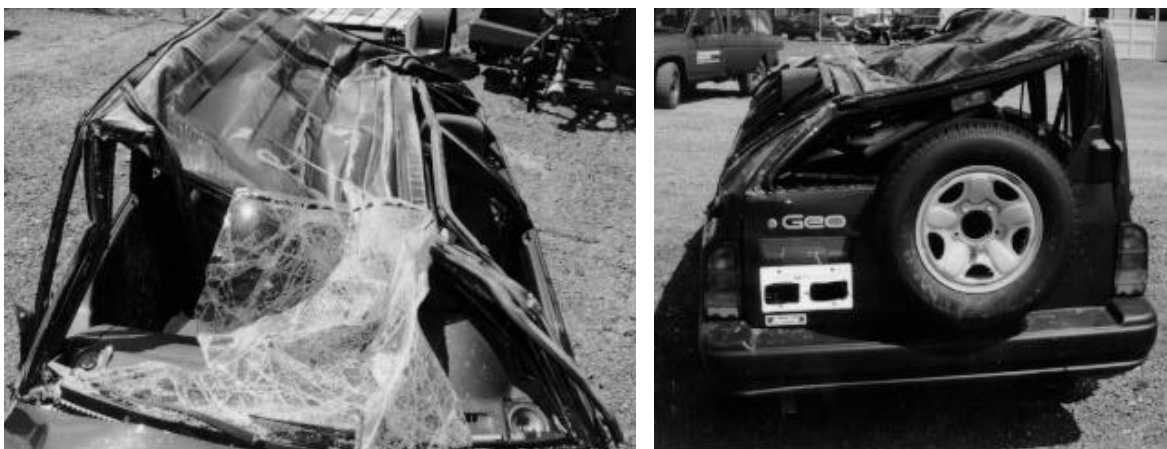
Figure 5: Roof Crush: 1997 Geo Tracker

Figure 5 illustrates two typical cases where the roof crush might be considered excessive given the collision circumstances. The 1997 Geo Tracker depicted in Figure 5, sustained its roof crush during a rollover with an estimated pre-impact speed of only 60-65 km/h. An interesting observation with this case is that the failure pattern of the left side of the roof suggests that the pillars were subjected to a lateral loading. This kind of load, which is common given the dynamics of rollover collisions, is not specifically reflected by the test procedures of *CMVSS 216*.

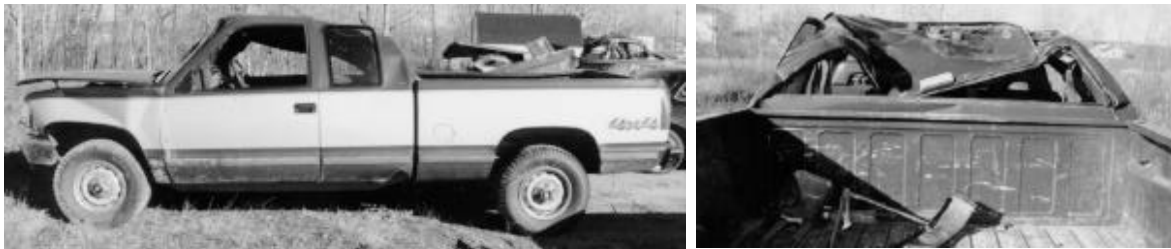
Figure 6: Roof Crush: 1997 Chevrolet Pickup

The 1993 Chevrolet pickup depicted in Figure 6 sustained excessive roof crush, particularly in the area over the rear bench seat. The case illustrates the long structural span that is often required of LTV roof systems given the provision of large window openings.

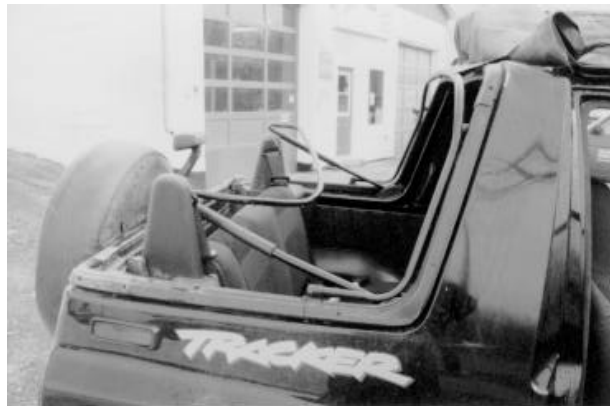
Figure 7: Lack of Protective Roof Structure

Figure 7 exemplifies a class of vehicles (convertibles) for which *CMVSS 216* does not apply. The 1995 Geo Tracker (soft-top) depicted was involved in a low speed rollover collision. Had there been any occupants in the rear seat, they would have been completely exposed given that there was no protective roof structure present. It is ironic to note the provision of mounting structures for the D-rings of three-point restraints for the outboard passengers, in the absence of any protective roof structure.

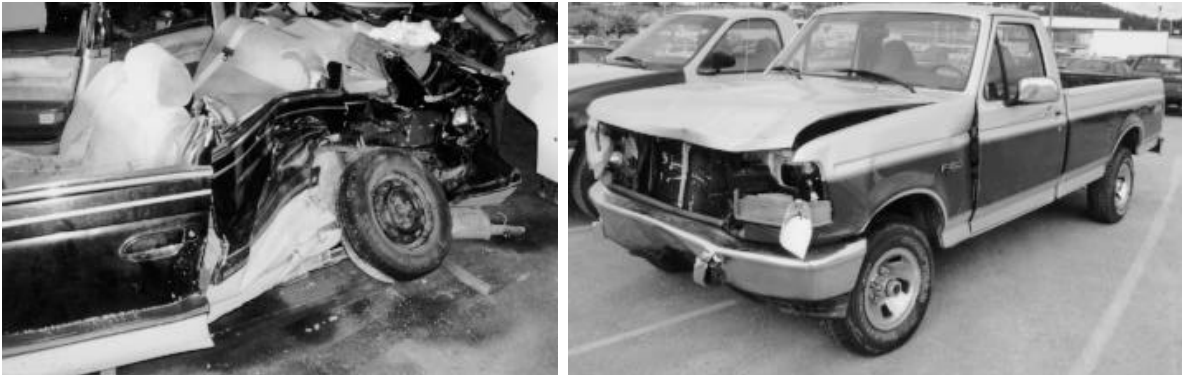
Figure 8: T-type Impact Damage Between Incompatible Vehicles

Figure 8 illustrates the consequences of incompatible vehicles. As shown, a 1996 Ford F-150 pickup struck the side of a 1989 Ford Taurus. Given the height and stiffness of the frame and bumper of the pickup, it overrode the sill level of the Taurus thereby exacerbating the intrusion into the rear occupant area.

Although vehicle size and mass are not likely to be regulated, a standard bumper height and stiffness, mandated through *CMVSS 215, Bumpers*, for all vehicle classes might prove beneficial. While the standard does govern the height of bumpers (between 400 and 500 mm) it currently only applies to passenger cars and not the multipurpose vehicle or truck classes.

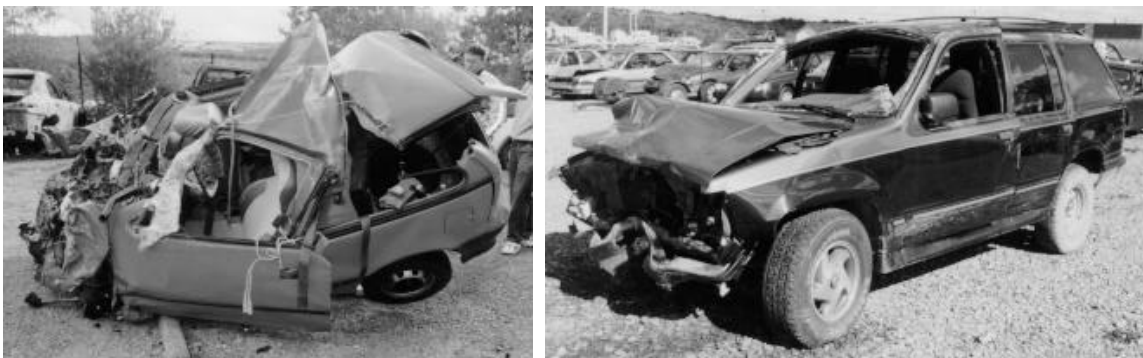
Figure 9: Head-on Impact Damage Between Incompatible Vehicles

Figure 9 depicts an example of a frontal collision between incompatible vehicles. The 1989 Pontiac Firefly and the 1993 Ford Explorer impacted in a head-on configuration. The Explorer overrode the front end of the Firefly because of its additional height and chassis stiffness. Note that the mass of the Explorer was nearly 2.6 times that of the Firefly.

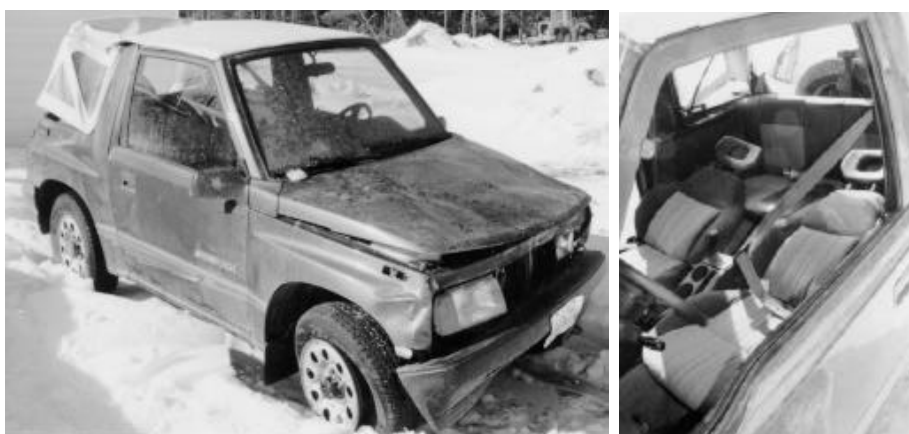
Figure 10: Seatback Failure

Ten of the sampled cases yielded observations of seatback failures. The most dramatic case was LTVS-1233 that involved a 1995 Suzuki Sidekick. After spinning out of control on an icy road the vehicle slid backwards striking a snowbank. Both the driver and passenger seatbacks failed, allowing the driver (despite being restrained) to be ejected out through the plastic rear window. The damage is depicted in Figure 10.

CMVSS 207, Seat Anchorages, dictates the static strength that a seat's anchorages and the seatback's self-locking hinge must withstand. The same standard that applies to passenger cars is set out for classes of LTVs. While it is unlikely that occurrences of seatback failures are any more prevalent in LTVs than passenger cars, the consequences may, on average, be more severe given the demonstrated frequent loss of occupant compartment integrity due to side and rear glazing.
